# Hypervelocity Impact Testing of IM7/977-3 with Micron-Sized Particles

J.G. Smith Jr.<sup>\*</sup>, D.C. Jegley<sup>†</sup>, and E.J. Siochi<sup>‡</sup>  
*NASA Langley Research Center, Hampton, VA 23681-2199*

**Ground-based hypervelocity impact testing was conducted on IM7/977-3 quasi-isotropic flat panels at normal incidence using micron-sized particles (i.e.  $\leq 100 \mu\text{m}$ ) of soda lime glass and olivine. Testing was performed at room temperature (RT) and 175°C with results from the 175°C test compared to those obtained at RT. Between 10 and 30 particles with velocities ranging from 5 to 13 km/s impacted each panel surface for each test temperature. Panels were ultrasonically scanned prior to and after impact testing to assess internal damage. Post-impact analysis included microscopic examination of the surface, determination of particle speed and location, and photomicroscopy for microcrack assessment. Internal damage was observed by ultrasonic inspection on panels impacted at 175°C, whereas damage for the RT impacted panels was confined to surface divets/craters as determined by microscopic analysis.**

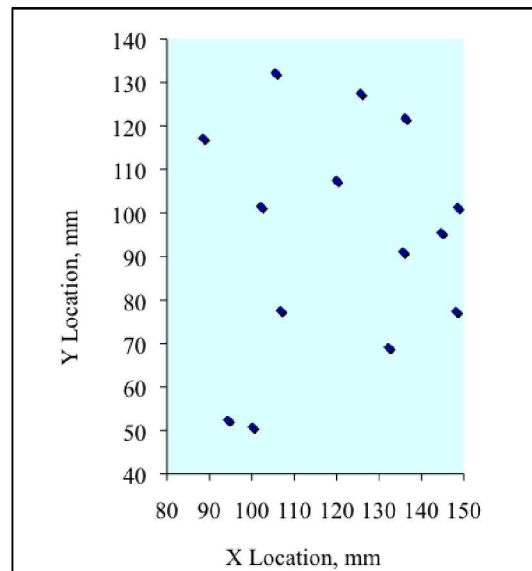
A total of 27 impacts were identified with velocities ranging between 4.8 to 13.2 km/s. Sixteen of the impacts were determined to be from SLG by inspection of the roundness of the corresponding witness film holes. However, 2 of these were too close together to individually assign discernable impact velocities. A graphical distribution of the 14 SLG impacts with known velocities is shown in Fig. 6. Not included in Fig. 6 are the other 11 impacts that were attributed to gun debris fibers (G10 fiberglass) and the 2 SLG particles with unknown velocities.

Figure 6. SLG impactor locations on the RT SLG FRPC test panel.

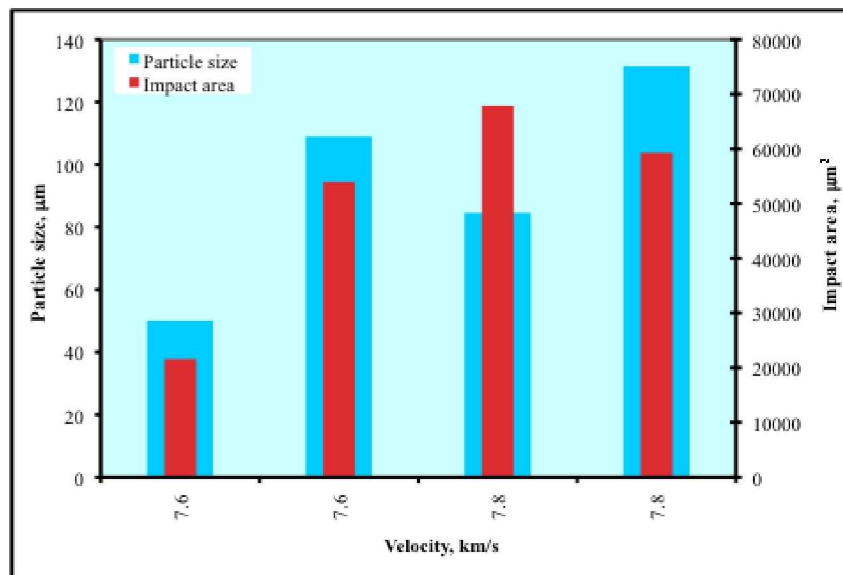
FRPC during the test (Table 5). The average calculated particle size was 102  $\mu\text{m}$  compared to 68  $\mu\text{m}$  in Table 2. The total calculated particle mass that impacted the panel was  $2.99 \times 10^{-5}$  g. No discernable trend was observed for particles of increasing size that were traveling at the same velocity with regards to impact area as shown in Fig. 8A. 2). It was observed though that as the velocity increased the impact area decreased for particles of approximately the

**Figure 8A. Particle size and impact area vs. velocity.**

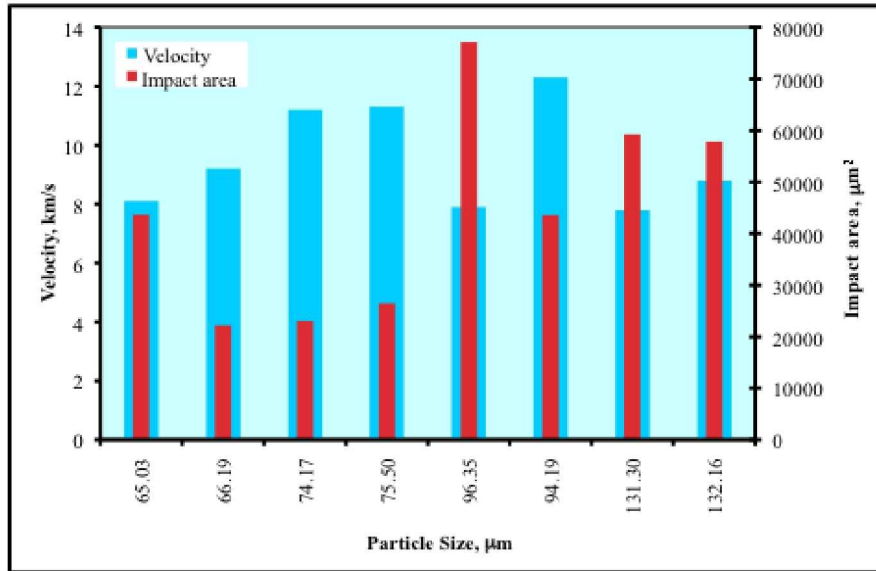
**Figure 8B. Velocity and impact area vs. particle size.**

same size shown in Fig. 8B. The impact area was comparable for particles that were approximately 75 μm in size traveling at similar velocities.

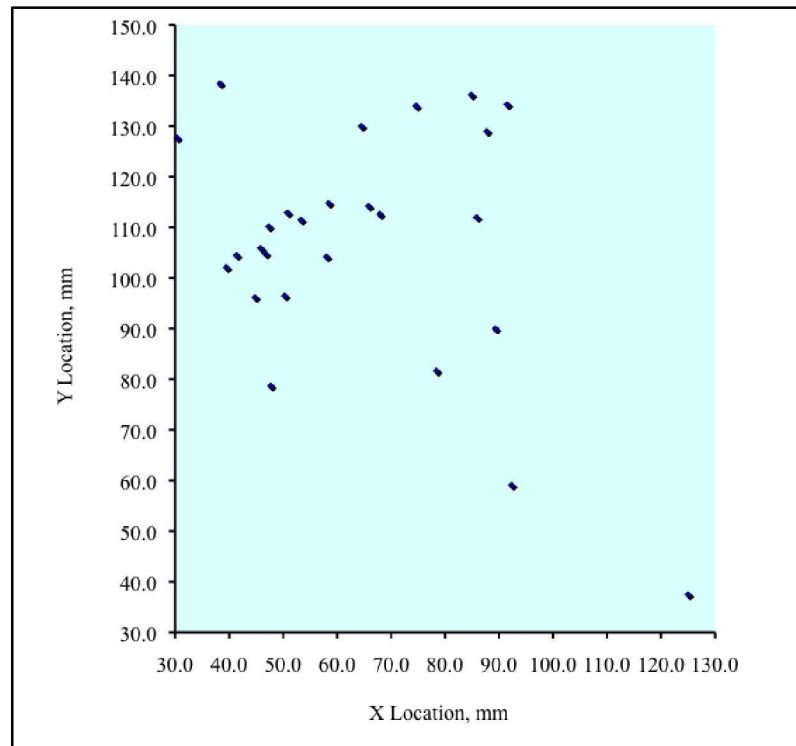
The test resulted in 33 impacts being recorded with velocities ranging from 4.9 to 12.8 km/s and were comparable to those observed for RT testing. For 26 of the impacts, the location, velocity, and impactor crater dimensions were determined. For the other 7 impacts, velocity data was not recorded by the PMT. A graphical representation of the impact locations due to the 26 SLG impactors with known velocities is shown in Fig. 11.

**Figure 11. SLG impactor locations on the ET FRPC test specimen.**

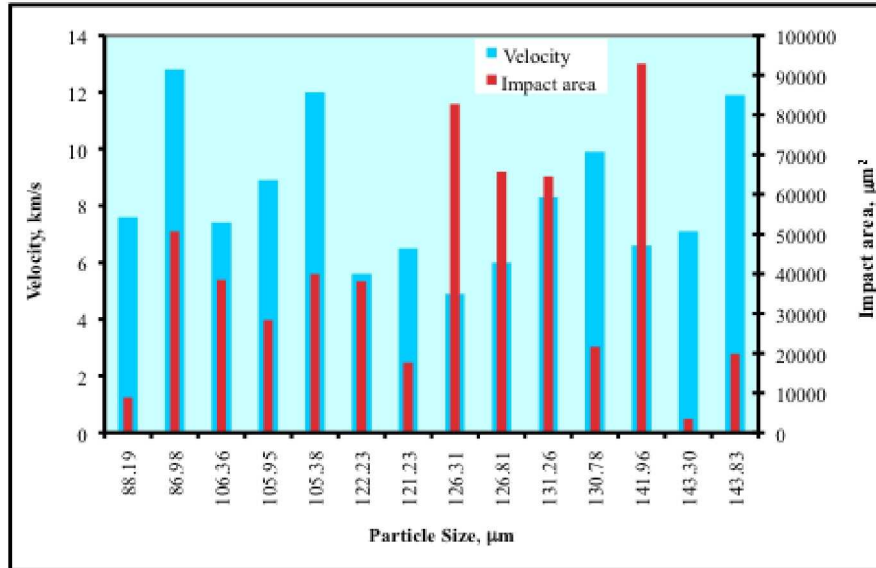
In general, particles that were approximately the same size in Table 6 exhibited a decrease in the impact area with increasing velocity. This result is shown in Fig. 14 and was similar to the RT SLG observation.

**Figure 14. Particle size and impact area vs. velocity.**

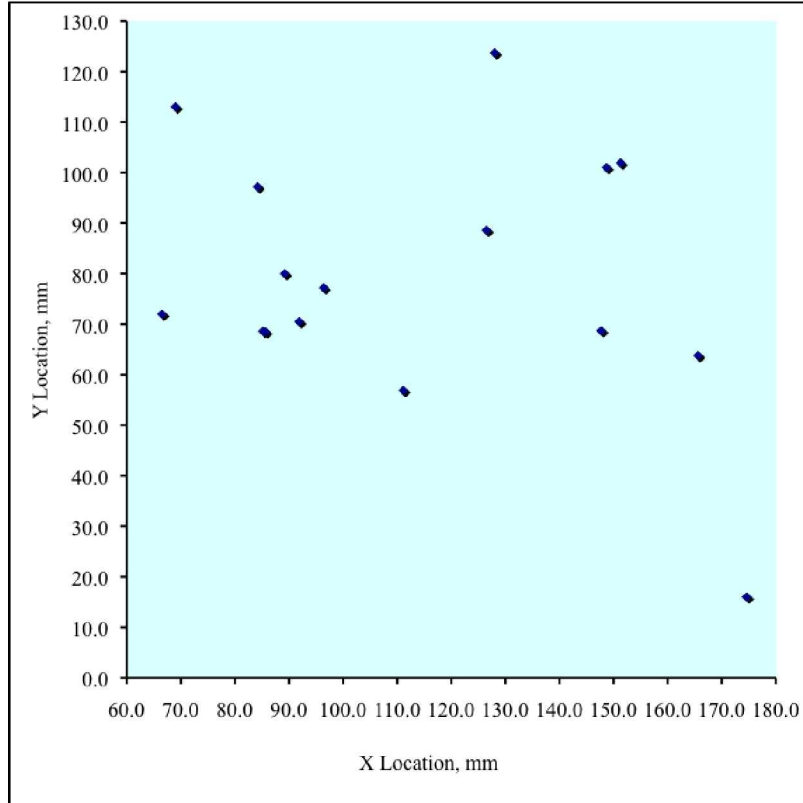
For this test, 19 OLV impacts were identified with velocities ranging from 7.7 to 13.3 km/s. For 3 of the impactors, velocity data was not recorded. A graph of the OLV impactor locations with known velocities is shown in Fig. 16.

**Figure 16. OLV impactor locations on the RT FRPC test specimen.**

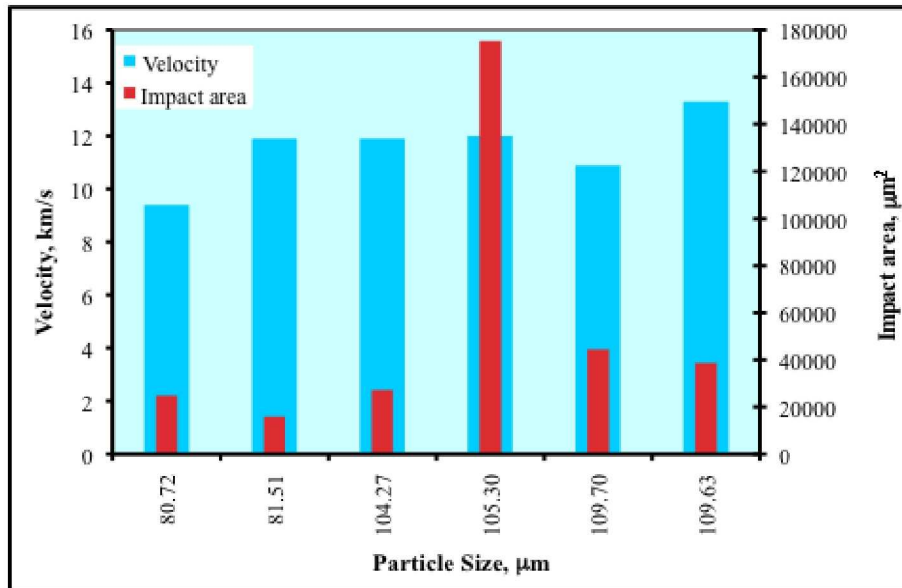
In general, particles of approximately the same size exhibited decreasing impact area with increasing velocity as shown in Fig. 18A. Similar results were observed for the SLG impactors. For particles that were approximately 105  $\mu\text{m}$  in size with similar velocity, the impact areas differed markedly in contrast to the SLG RT results where the

**Figure 18A. Velocity and impact area vs. particle size.**

impact areas were comparable for similar particle size and velocity. Since the particle size is determined from the witness film, the OLV impactor could have fractured prior to impact resulting in a smaller particle size and thus may account for the different impact areas.

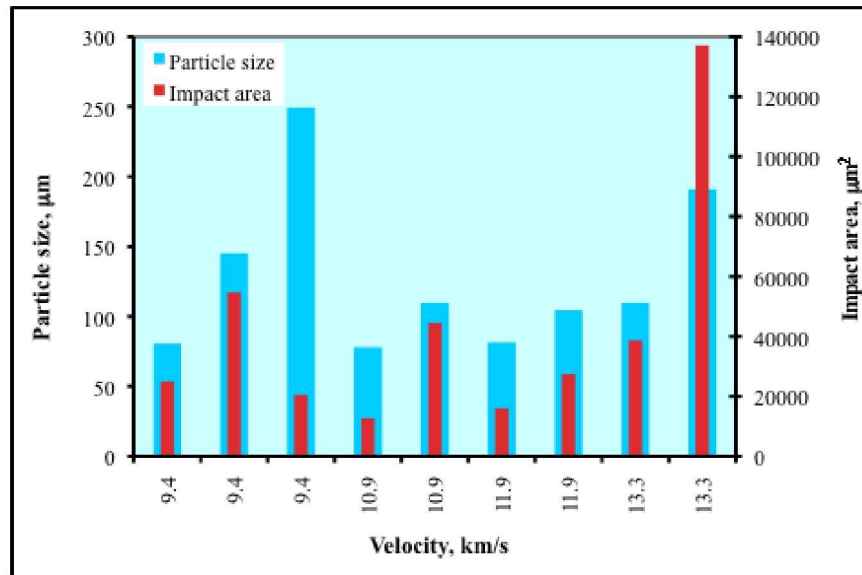
The impact area generally increased with increasing particle size for impactors traveling at the same velocity as shown in Fig. 18B. The lower impact area displayed by the particle size of 249  $\mu\text{m}$  traveling at 9.4 km/s may be due to this particle fracturing prior to impact as cited above.

**Figure 18B. Particle size and impact area vs. velocity.**

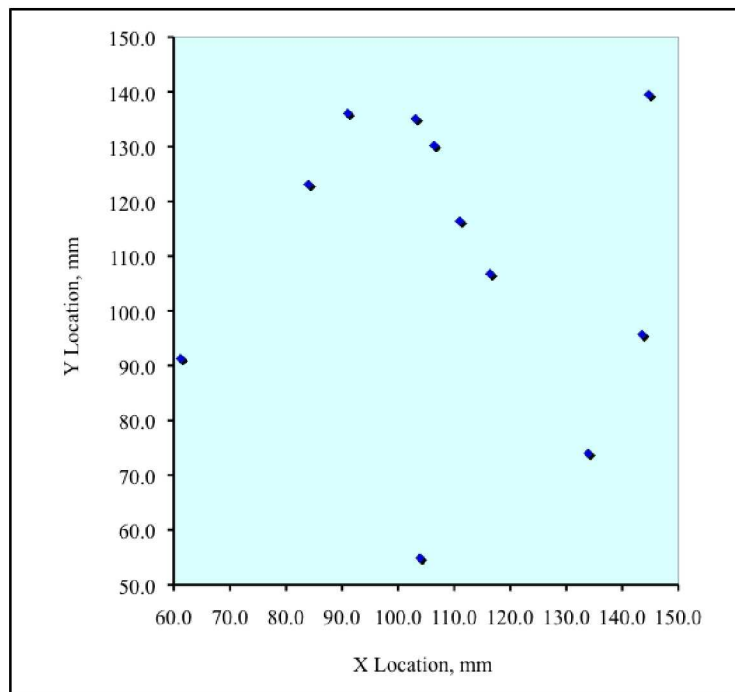
Eleven impacts were recorded with the corresponding locations shown in Fig. 20. The impactors had velocities ranging from 7.5 to 13.9 km/s and were comparable to RT OLV impact velocities.

**Figure 20. OLV impactor locations on the ET FRPC test specimen.**

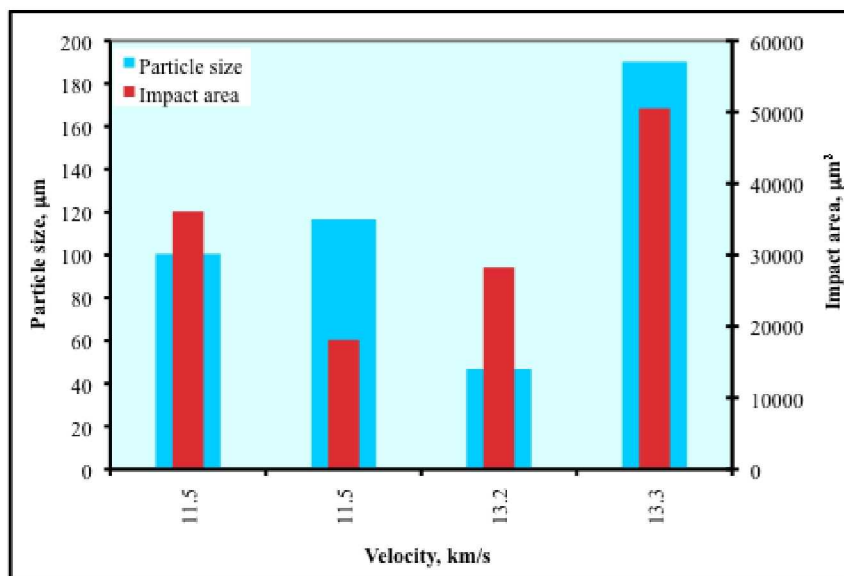
For impactors traveling at the same velocity, the impact area did not follow a trend for increasing particle size as shown in Figure 23. One possible explanation for this result is that the particle could have fractured prior to impact resulting in a smaller particle size than the one calculated from witness film dimensions.

**Figure 23. Particle size and impact area vs. velocity.**
